### G6935.01-113-11-R0 ACOUSTICAL PERFORMANCE TEST REPORT ASTM E90

CUSTOM VINYL PRODUCTS, LLC

SERIES/MODEL: Veka DHA4

**TYPE: Double Hung Window**

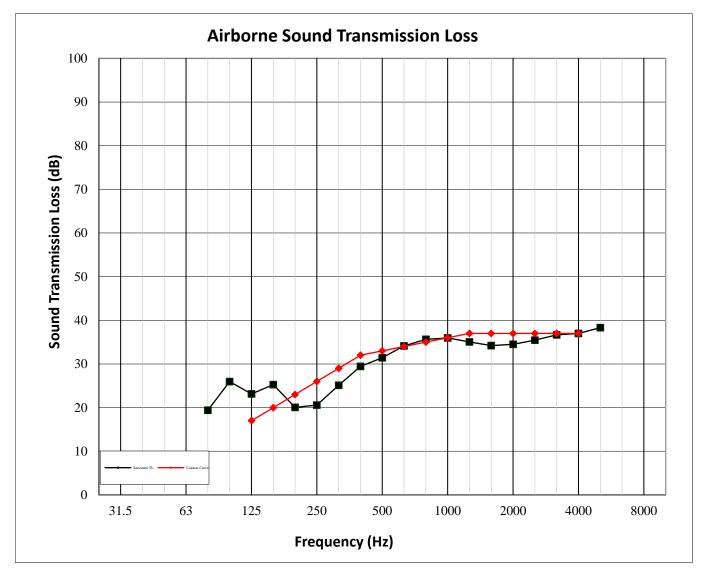
# AIRBORNE SOUND TRANSMISSION LOSS

Test Date	01/17/17						
Data File No.	G6935.01						
Client	Custom Vinyl Products, LLC						
Description	Series/Model: V space, 1/4" ann		hung window w	vith 7/8" IG (1/8" annealed	exterior, 1/2'	" air	
Specimen Area	1.80 m <sup>2</sup>	Receive Temp.	21.0 °C	Source Temp.	21.1 °C		
Technician	Matthew D. Tre	Receive Humidity	54%	Source Humidity	53%

Freq	Background SPL	Absorption	Source	Receive	Specimen	95%	Number
			SPL	SPL	TL	Confidence	of
(Hz)	(dB)	(m²)	(dB)	(dB)	(dB)	Limit	Deficiencies
80	39.5	5.0	105	82	19.4	1.51	-
100	37.0	5.5	105	75	26.0	1.46	-
125	38.6	5.0	104	77	23.1	1.36	0
160	41.5	4.6	105	76	25.3	0.54	0
200	40.3	4.7	106	82	20.1	0.45	3
250	35.1	5.4	106	81	20.6	0.82	5
315	29.2	5.4	99	69	25.1	0.34	4
400	24.8	5.8	96	62	29.4	0.35	3
500	21.2	5.8	97	60	31.4	0.25	2
630	19.1	5.5	101	62	34.1	0.26	0
800	17.5	5.9	100	60	35.7	0.17	0
1000	13.1	6.1	97	55	36.0	0.37	0
1250	11.6	6.6	97	56	35.0	0.29	2
1600	9.1	7.0	101	61	34.2	0.17	3
2000	7.5	7.4	95	54	34.5	0.22	2
2500	7.4	8.4	93	51	35.5	0.15	2
3150	8.2	10.1	96	52	36.7	0.24	0
4000	10.0	12.3	95	50	37.0	0.24	0
5000	11.6	15.8	94	46	38.3	0.29	-
STC Rating	33	(Sound Trans	mission Class)

26 (Sum of Deficiencies)

28 (Outdoor-Indoor Transmission Class)

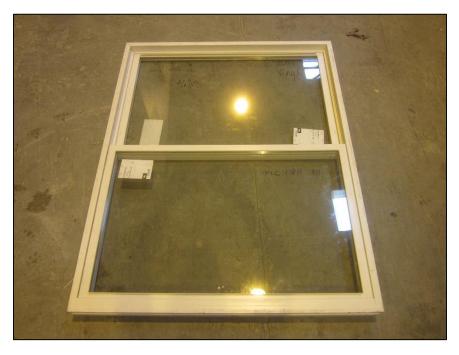
Interior View of Specimen

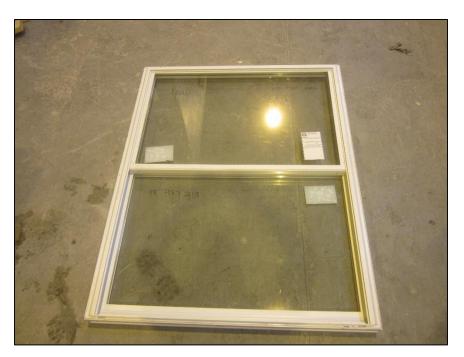
**Exterior View of Specimen**
